AN INVESTIGATION OF THE FORMATION
OF PLASTIC HINGES IN SIMPLE
RIGID FRAMES

WILLIAM E. MONAGHAN AND
THOMAS C. WILLIAMS

Submitted to
The Faculty of Rensselaer Polytechnic Institute
in partial fulfillment of the requirements for
the degree of
Master of Civil Engineering

June, 1951
Troy, New York

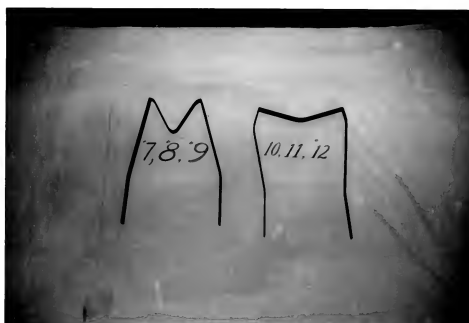
FIGURE 12 B

The problem of trying to predict the value of load which would cause the entire structure to become a mechanism is highly complicated. However, it is an easy matter to calculate the load required to bring the structure to a complete state of collapse as in Figure 12-B. However, it must be remembered that this is not the load required to transform the structure into a mechanism but is somewhat larger.

$$\sum M_A = 0$$

$$P/2 \times 1/2 = 4 - 1 + \frac{4 \times \sqrt{3}}{2}$$

$$P = 25.8$$

We felt that it would be interesting to check our calculations as in Figure 12-B by loading to a complete state of collapse two of the frames. We predicted by our calculations that a load of 339 pounds ($25.8 \times 13.13 = 339$) would completely collapse the frames. The actual failure load turned out to be 347 pounds.
